15. Supplementary Notes			
16. Abstract  About 11:06 p.m. on June 5, 1975, a Reading Company commuter train struck a tractor-semitrailer (truck) at a grade crossing near Yardley, Pennsylvania. The truck was transporting three coils of steel, two of which penetrated the first commuter car. The three occupants of the lead car were killed and an occupant of the second car was injured slightly. The truckdriver was uninjured. The semitrailer was torn from the tractor and damaged beyond repair and the lead commuter car was damaged extensively.  At the time of the collision, the automatic grade crossing signal system was functioning. The truckdriver said he had not seen or heard the warning signals.  The National Transportation Safety Board determines that the probable cause of the accident was the failure of the truckdriver to stop the truck in accordance with the warning signals.

About 11:06 p.m. on June 5, 1975, a Reading Company commuter train struck a tractor-semitrailer (truck) at a grade crossing near Yardley, Pennsylvania. The truck was transporting three coils of steel, two of which penetrated the first commuter car. The three occupants of the lead car were killed and an occupan

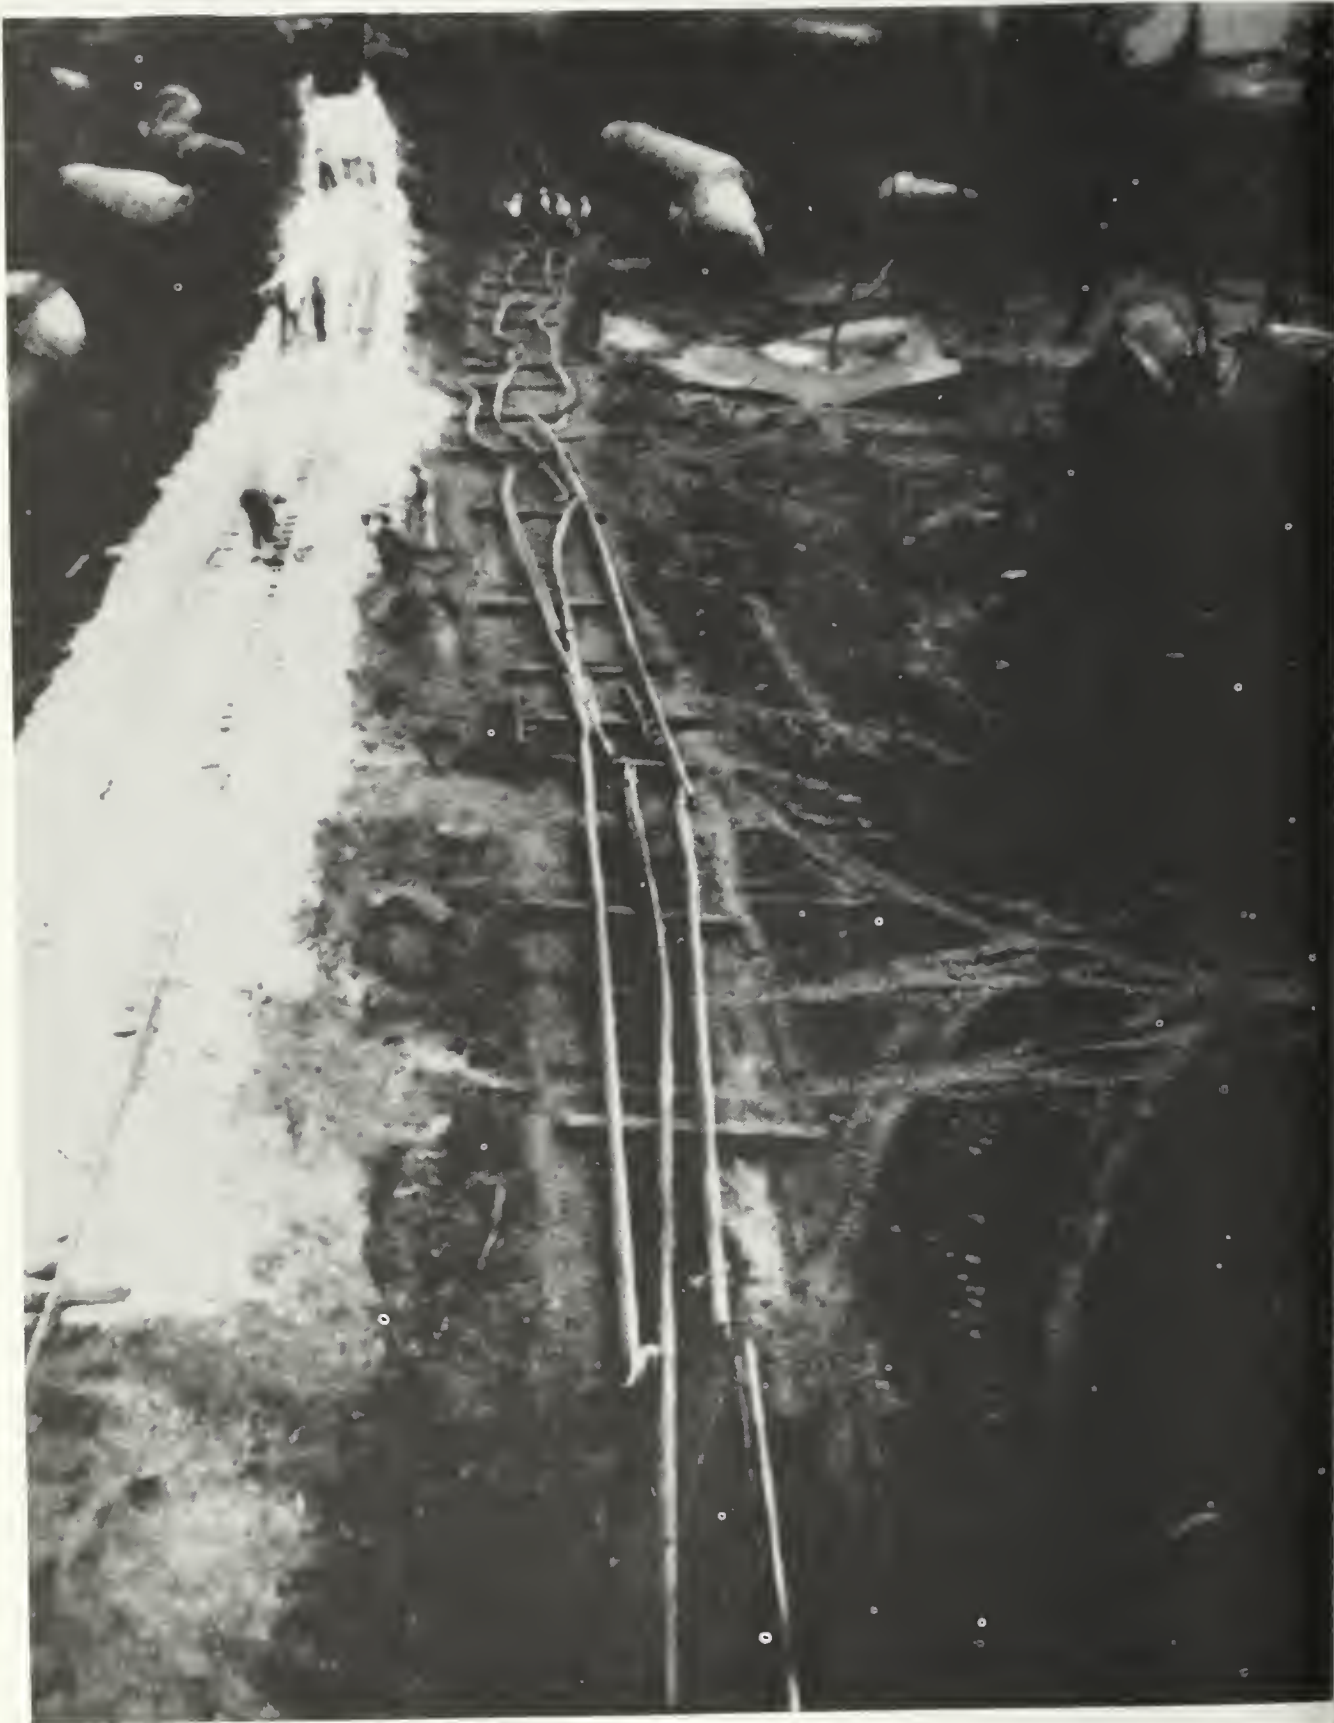
Figure 3. Reconstructed track structure.

In order to follow such a route, the left rear wheels of car 26 or the left lead wheels of car 27 would have to follow the flangeway of the frog to the left. This could occur if the guardrail gauge is less than standard or greater than standard; the guardrail could have become ineffective if it was moved by continued impact of wheels on the flare of the receiving end or if the filler block on the receiving end was struck by something. It also could occur if train dynamics lift a wheel upward and to the left at the frog point; however, because of the heavy weight of the tank cars, it is unlikely that a wheel was lifted.

Unusual compressive forces, resulting from unequal braking in light and heavy cars, could have contributed to the excursion of wheels to the left of the frog point. The heavy wheel marks on the toe filler block of

the frog and the receiving end of the guardrail were made by derailed wheels which followed the initially derailed cars. Since there were no marks of derailed wheels on crossties or rails which led to the marked filler block or the guardrail, the marks must have resulted from wheels which left the track because of a severe compressive force that caused the wheels to jump the track and subsequently strike the frog and guardrail. The bunching action behind a car or cars which had derailed at the frog could have initiated these events.

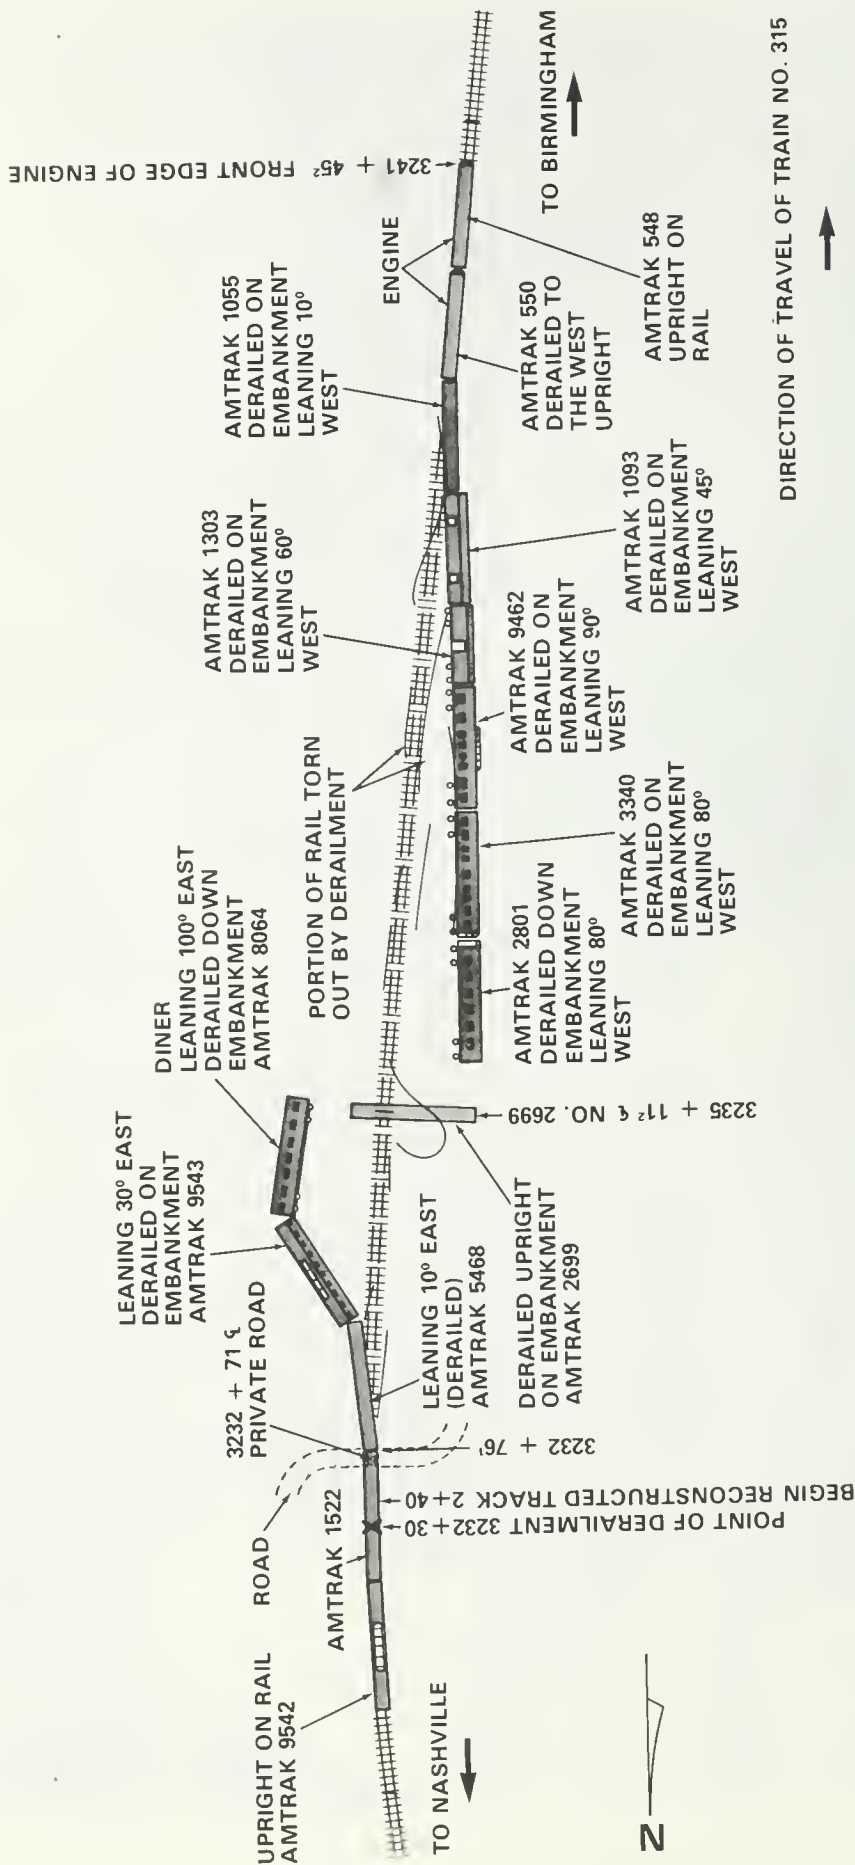
Figure 3. L & N Railroad Company M. P. B. A. 258.1 Frankewing, Tenn., derailment AMTRAK train No. 315, October 1, 1975, curvature 3° 8' R.

The National Transportation Safety Board determines that the probable cause of this accident was the overturning of the outside rail in a 3° 8' curve by high lateral forces induced by the six-wheel truck of the SDP-40-F locomotive; these forces exceeded the capability of the track which met current FRA standards. The speed of the locomotive, although not greater than the speed allowable for Class 4 track, was too great to be sustained by the track.

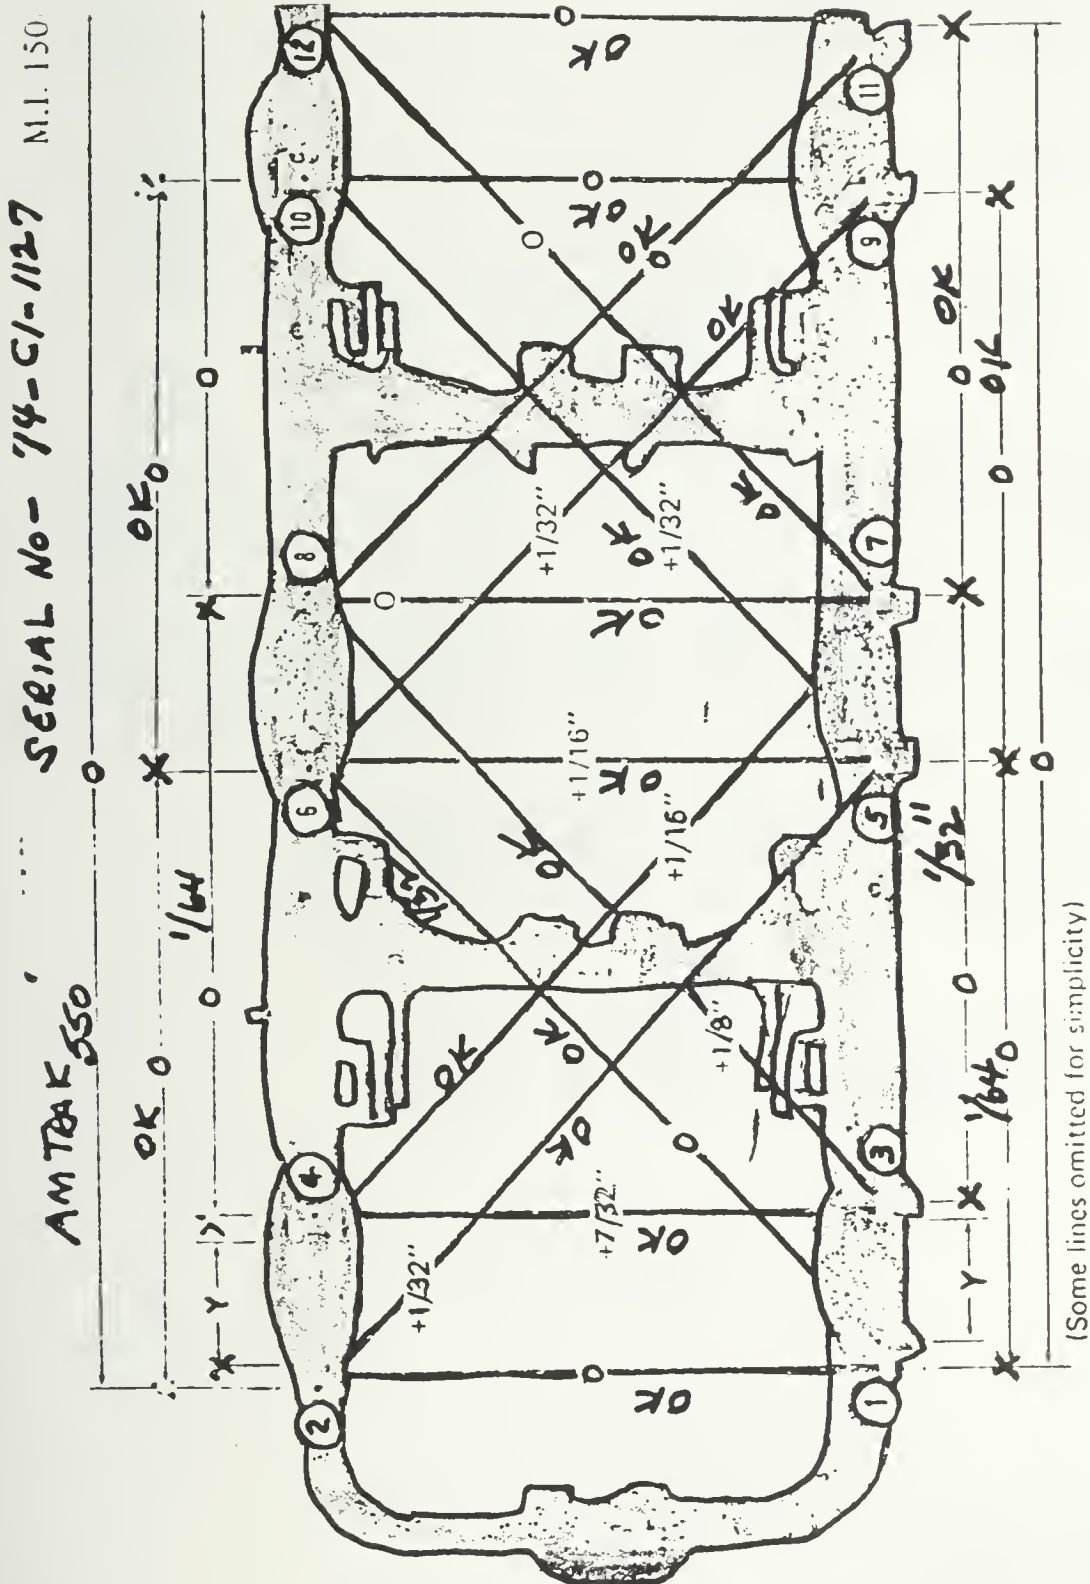
Truck measurements of locomotive 550.

the wheels had been derailed and that they had struck track angle bars, tie plates, and spikes. All wheels on unit 550 had been scarred by the derailment. The trucks of unit 550 were removed from the body assembly and its critical clearances and distances, as designated by the manufacturer, were measured. All measurements were within the design specifications or tolerances. No defects that could have caused the accident were found. (See Appendix B.)

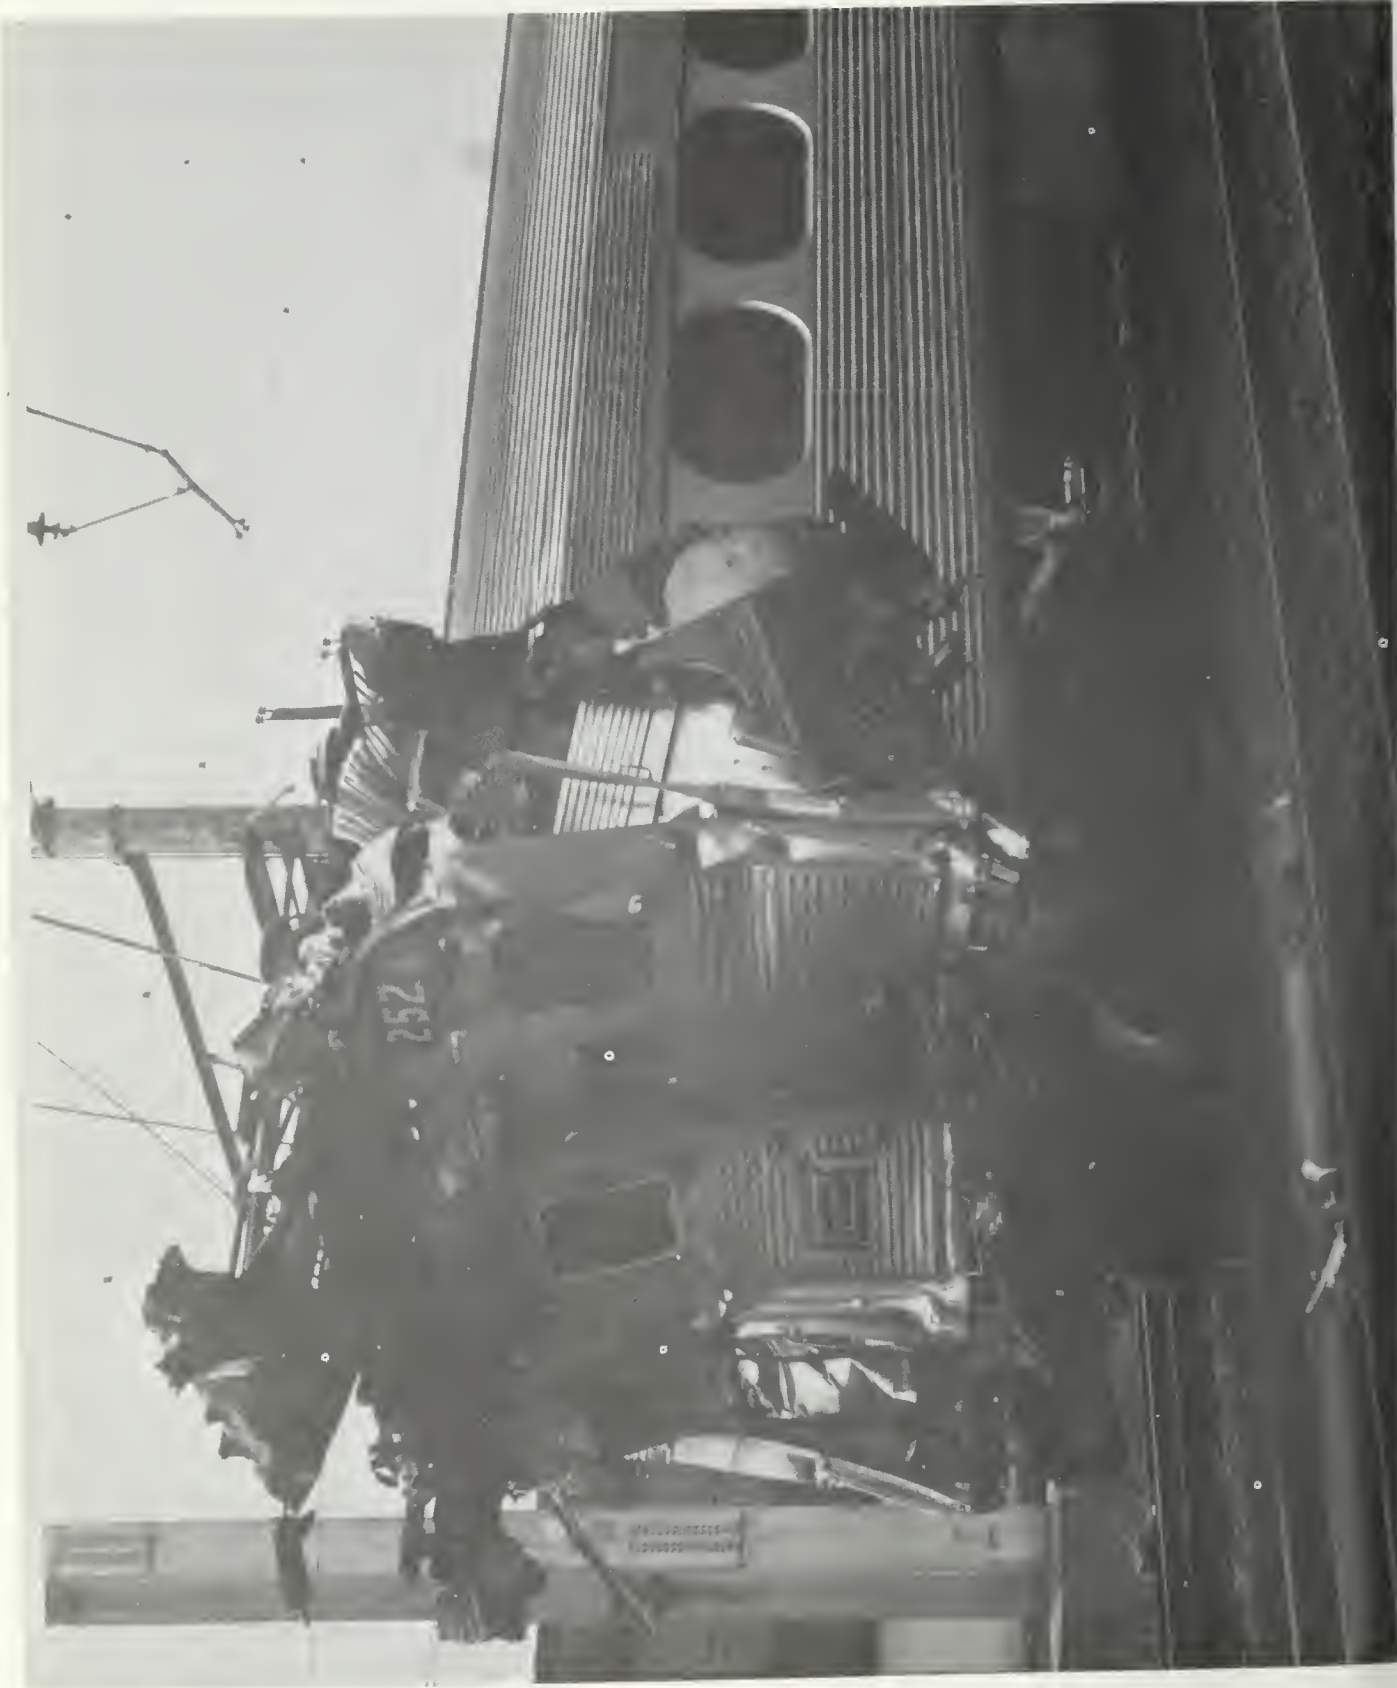
buffer structure of the Metroliner to contact and shear the Silverliner collision post, resulting in collapsing of the vestibule of the Silverliner. Since the buffer of the Metroliner was pushing the end structure of the Silverliner away from its own striker, the contact between the end sheets of the Silverliner and the Metroliner was minimized, resulting in minimal damage to the Metroliner end."

Train No. 939's lead car, No. 686, was slightly damaged as it scraped protruding equipment. The train did not derail.

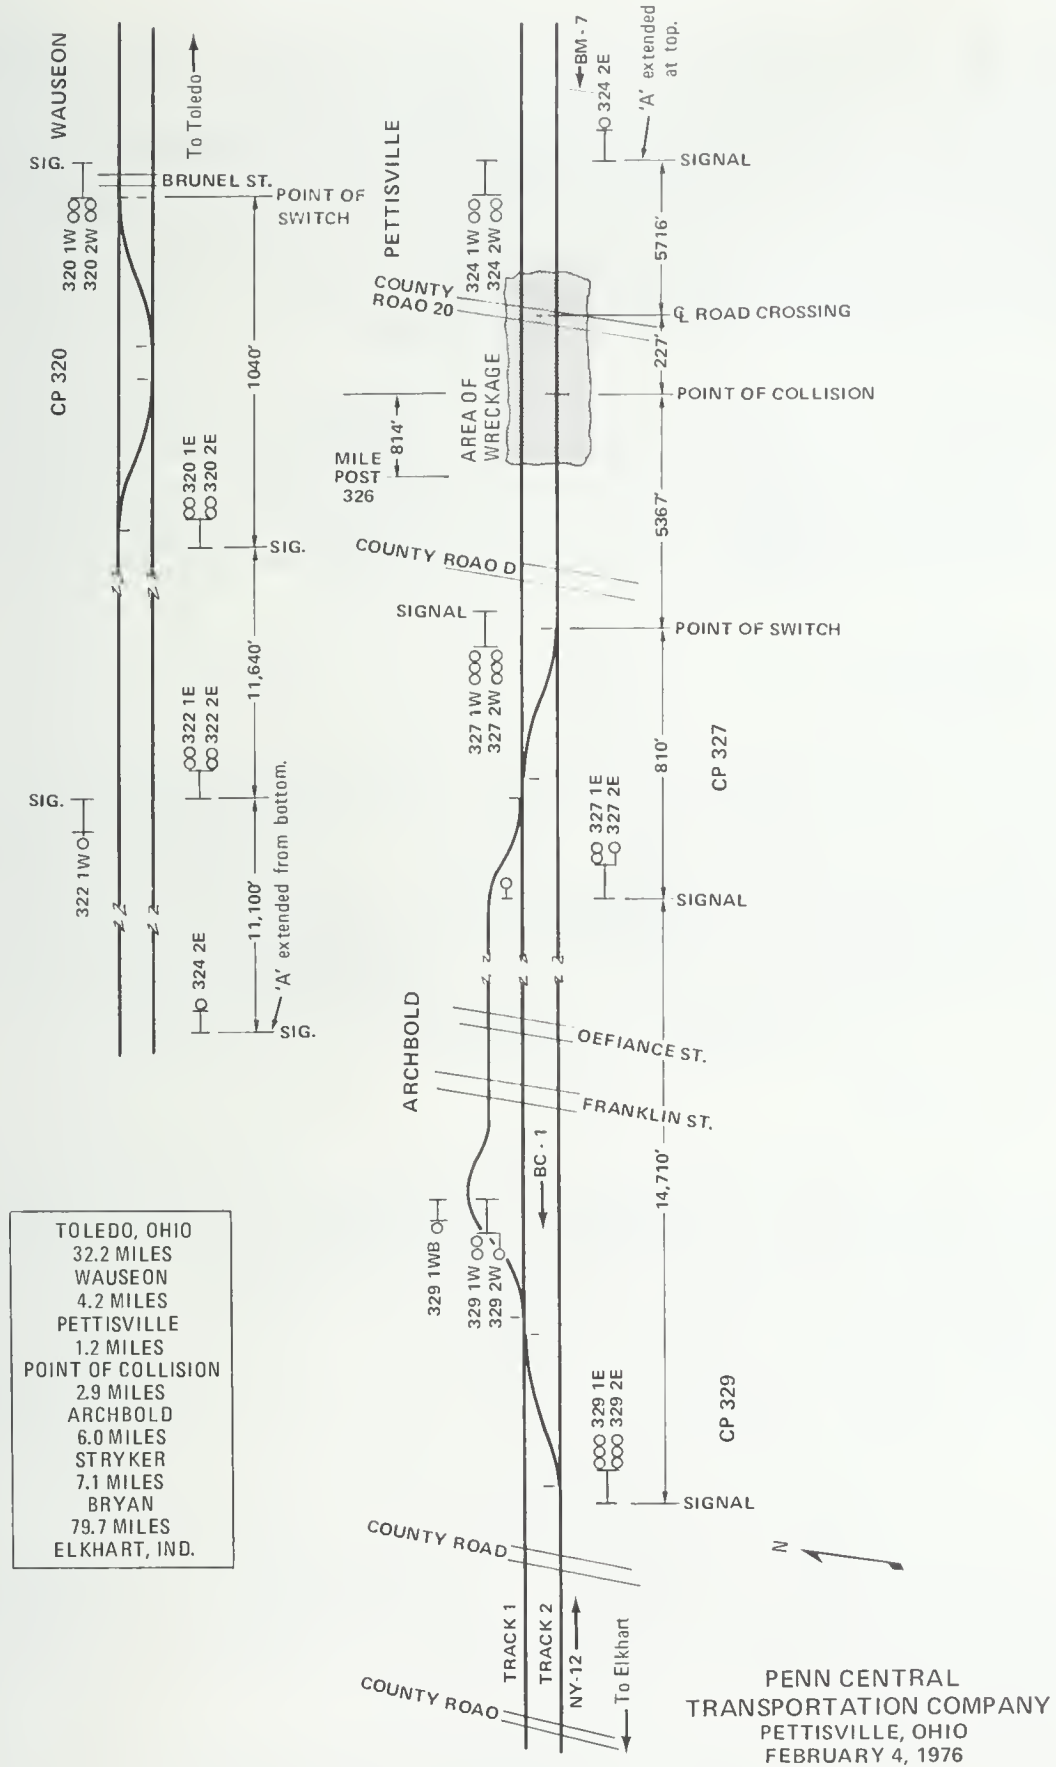
Figure 1. Track layouts at and near accident site.

About 400 feet of track 2 and 100 feet of track 1 were damaged. The switch of the crossover at CP 327 was damaged when train NY-12 ran through the switch after it was lined for the crossover movement. The operating rod was bent; this caused the far switch point 2/ to gap open about three-fourths of an inch. A portion of the head of the near switch point, opposite the point that had gapped open, was broken.

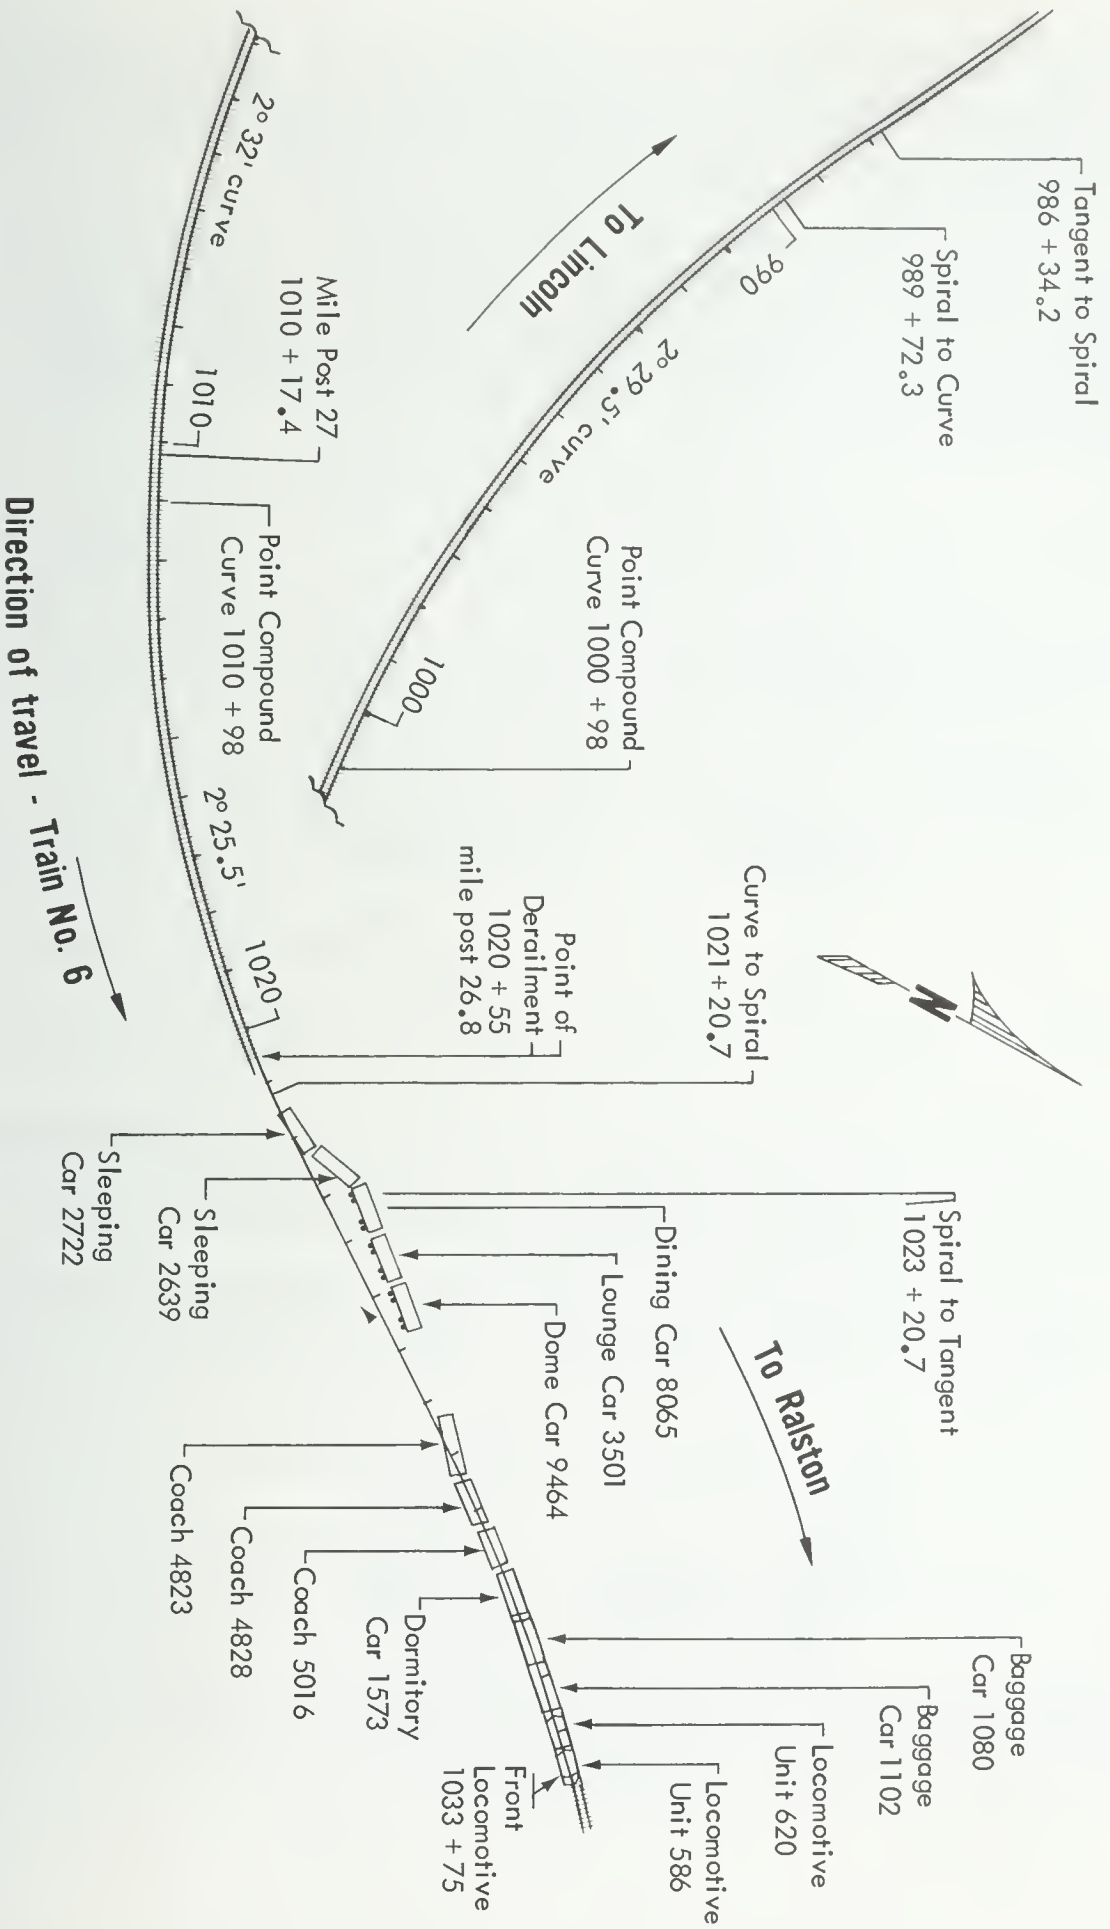
Fig. 1. Plan of the track.

On August 9, 1976, the BN track geometry car was used to inspect the track, and an excessive 3° alignment variation was detected in the derailment area. However, track inspectors stated they could not visually detect the variation, so no corrective action was taken.

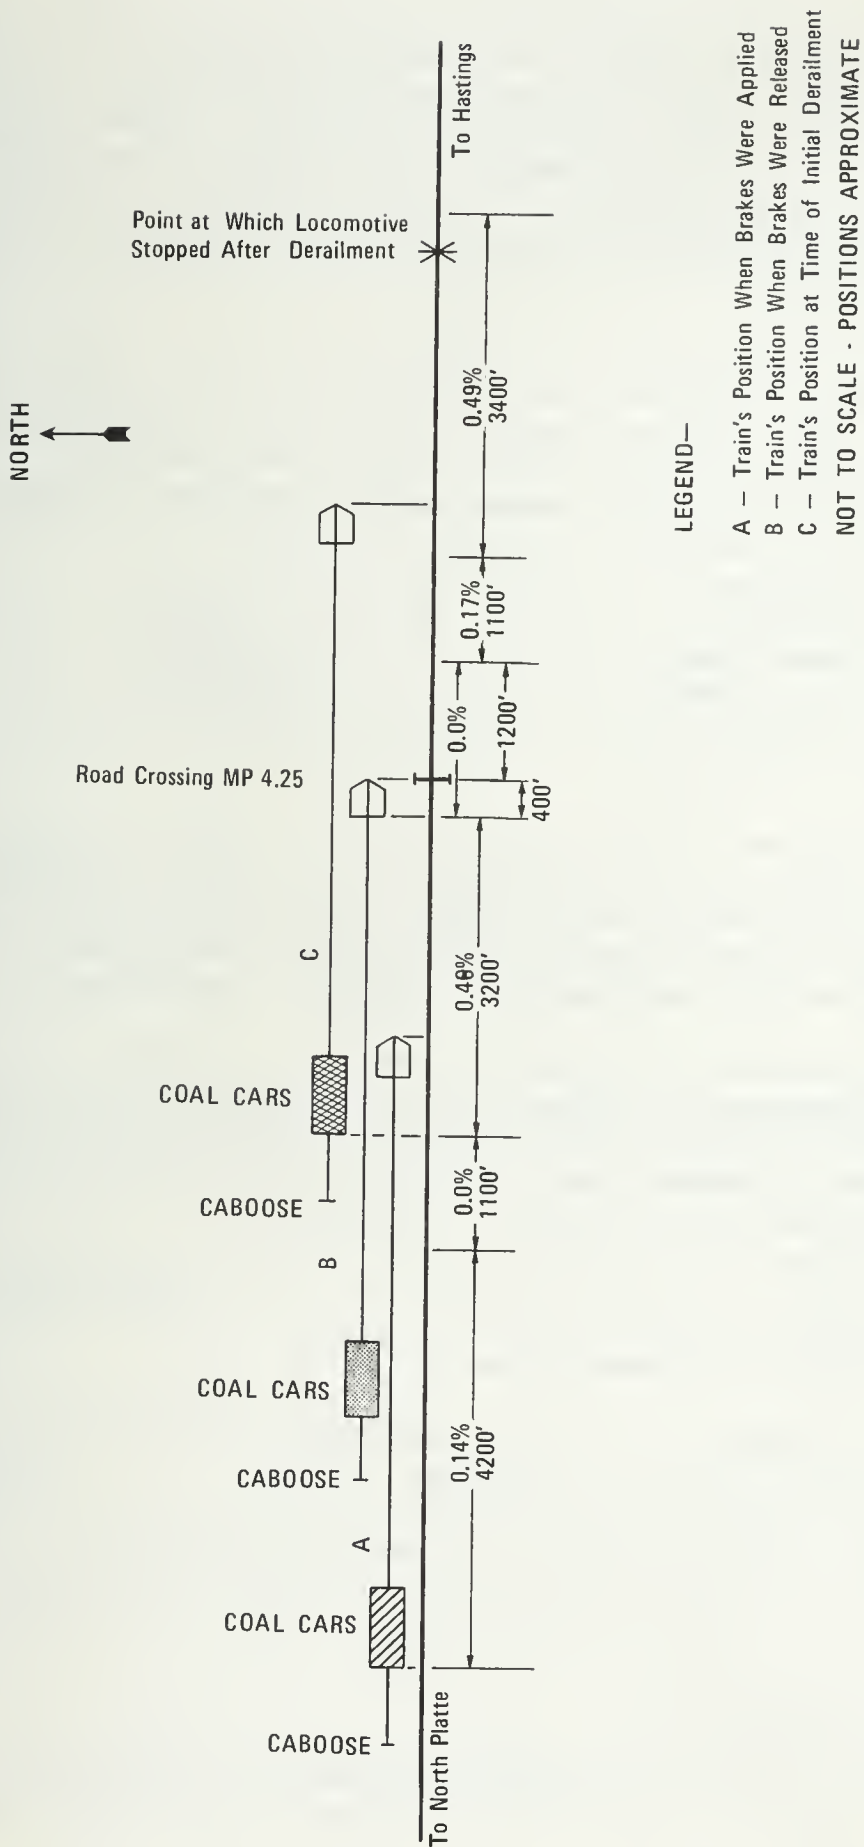
Figure 1. Plan of accident site.

The track is straight from milepost 16.5 west of Hastings through the derailment area and is built on slight cuts and fills (See figure 1). The track is maintained to the Federal Railroad Administration (FRA) Class 5 track standard.

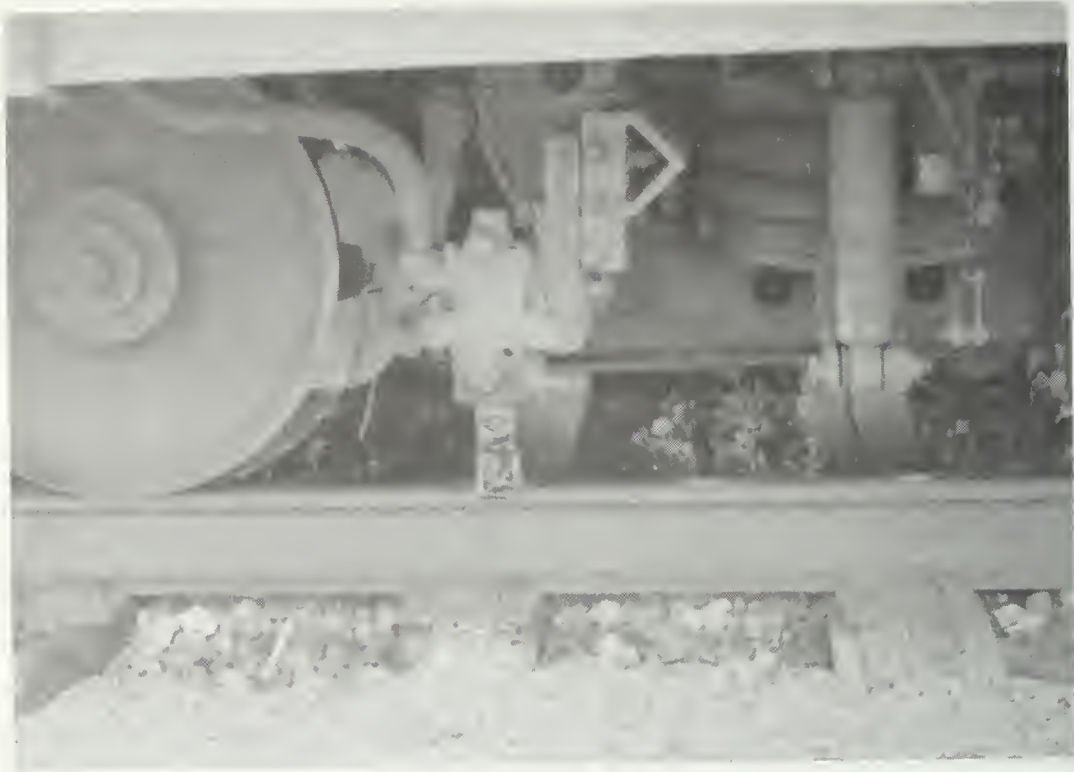
Figure 3. Automatic train stop arm on RTA car.

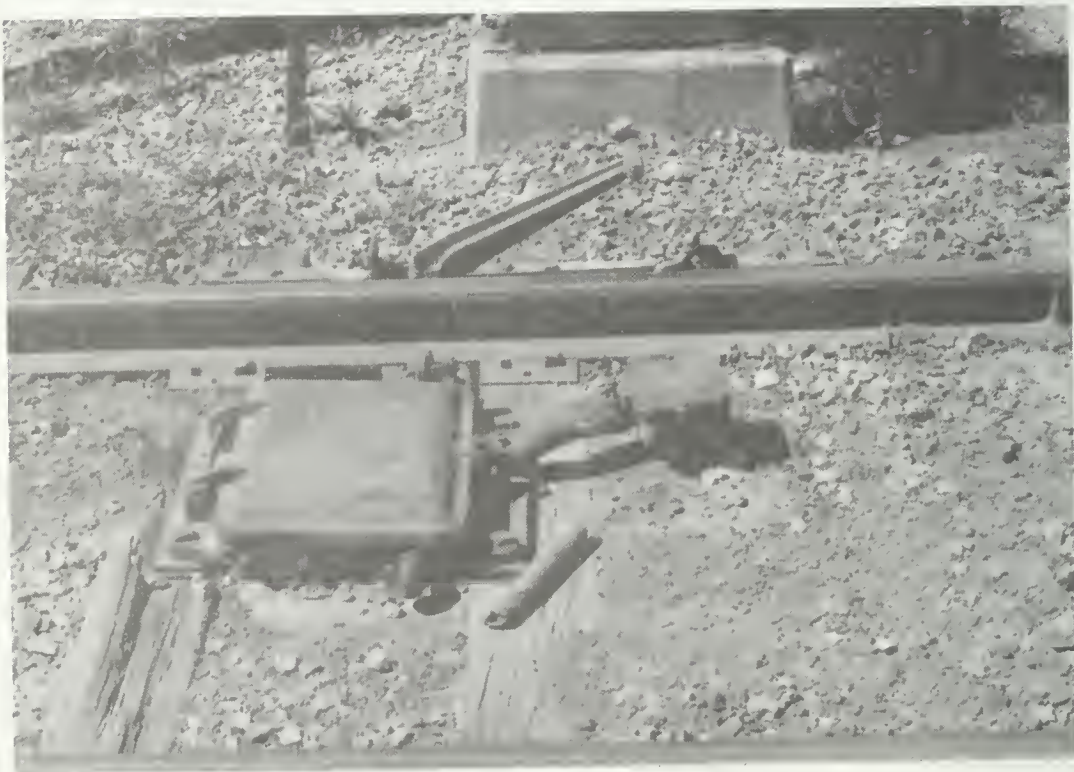
Figure 4. Wayside trip arm in trip position.

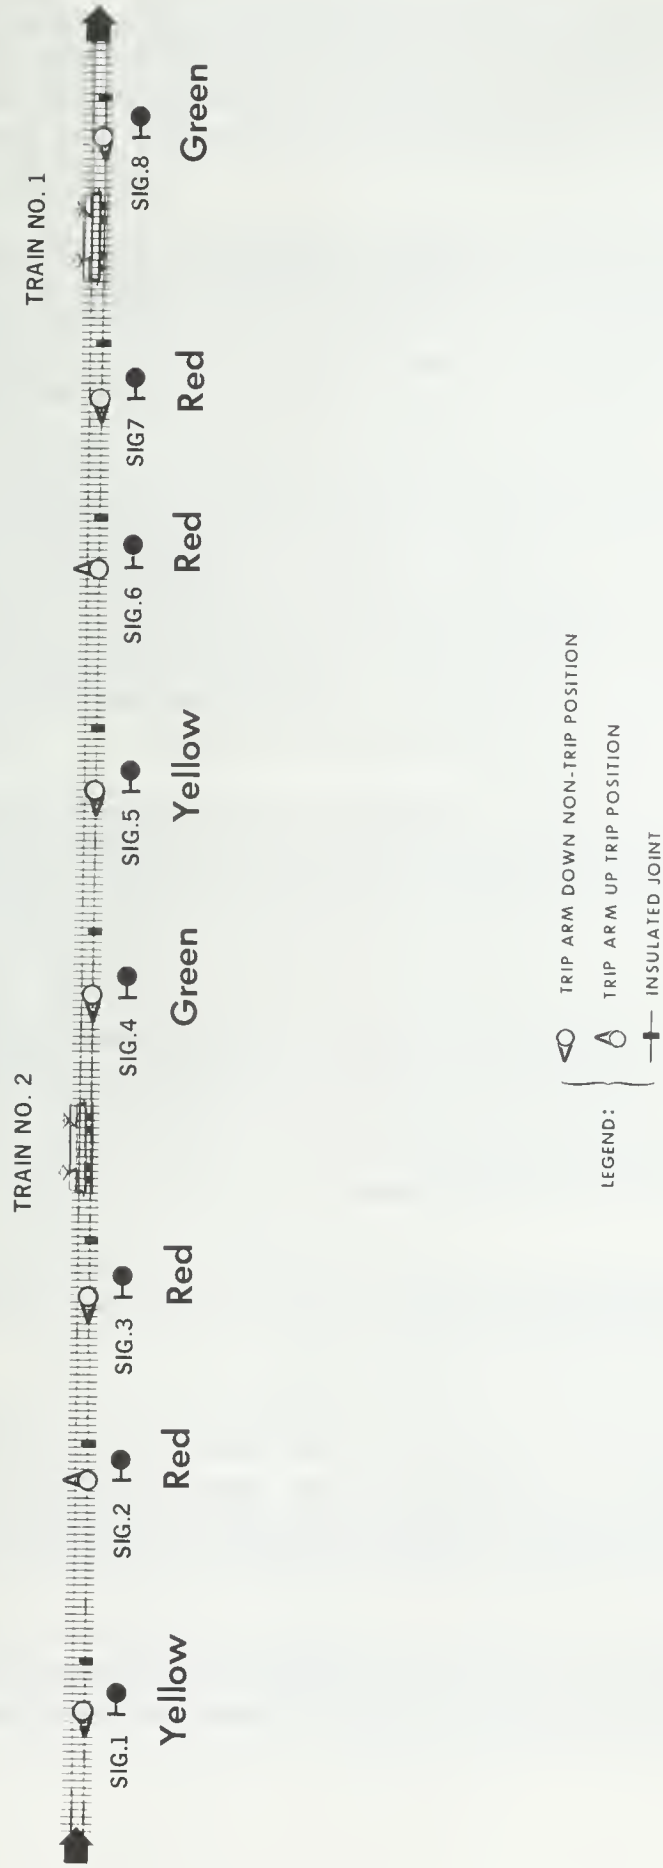
A train in ATS territory is always protected from a following train by at least two red signals. The trip arm at the second red signal behind the train is raised, but the trip arm at the signal at the entrance to the occupied block is not raised. (See figure 5.)

Figure 5. Operational sequence of automatic trip stops.

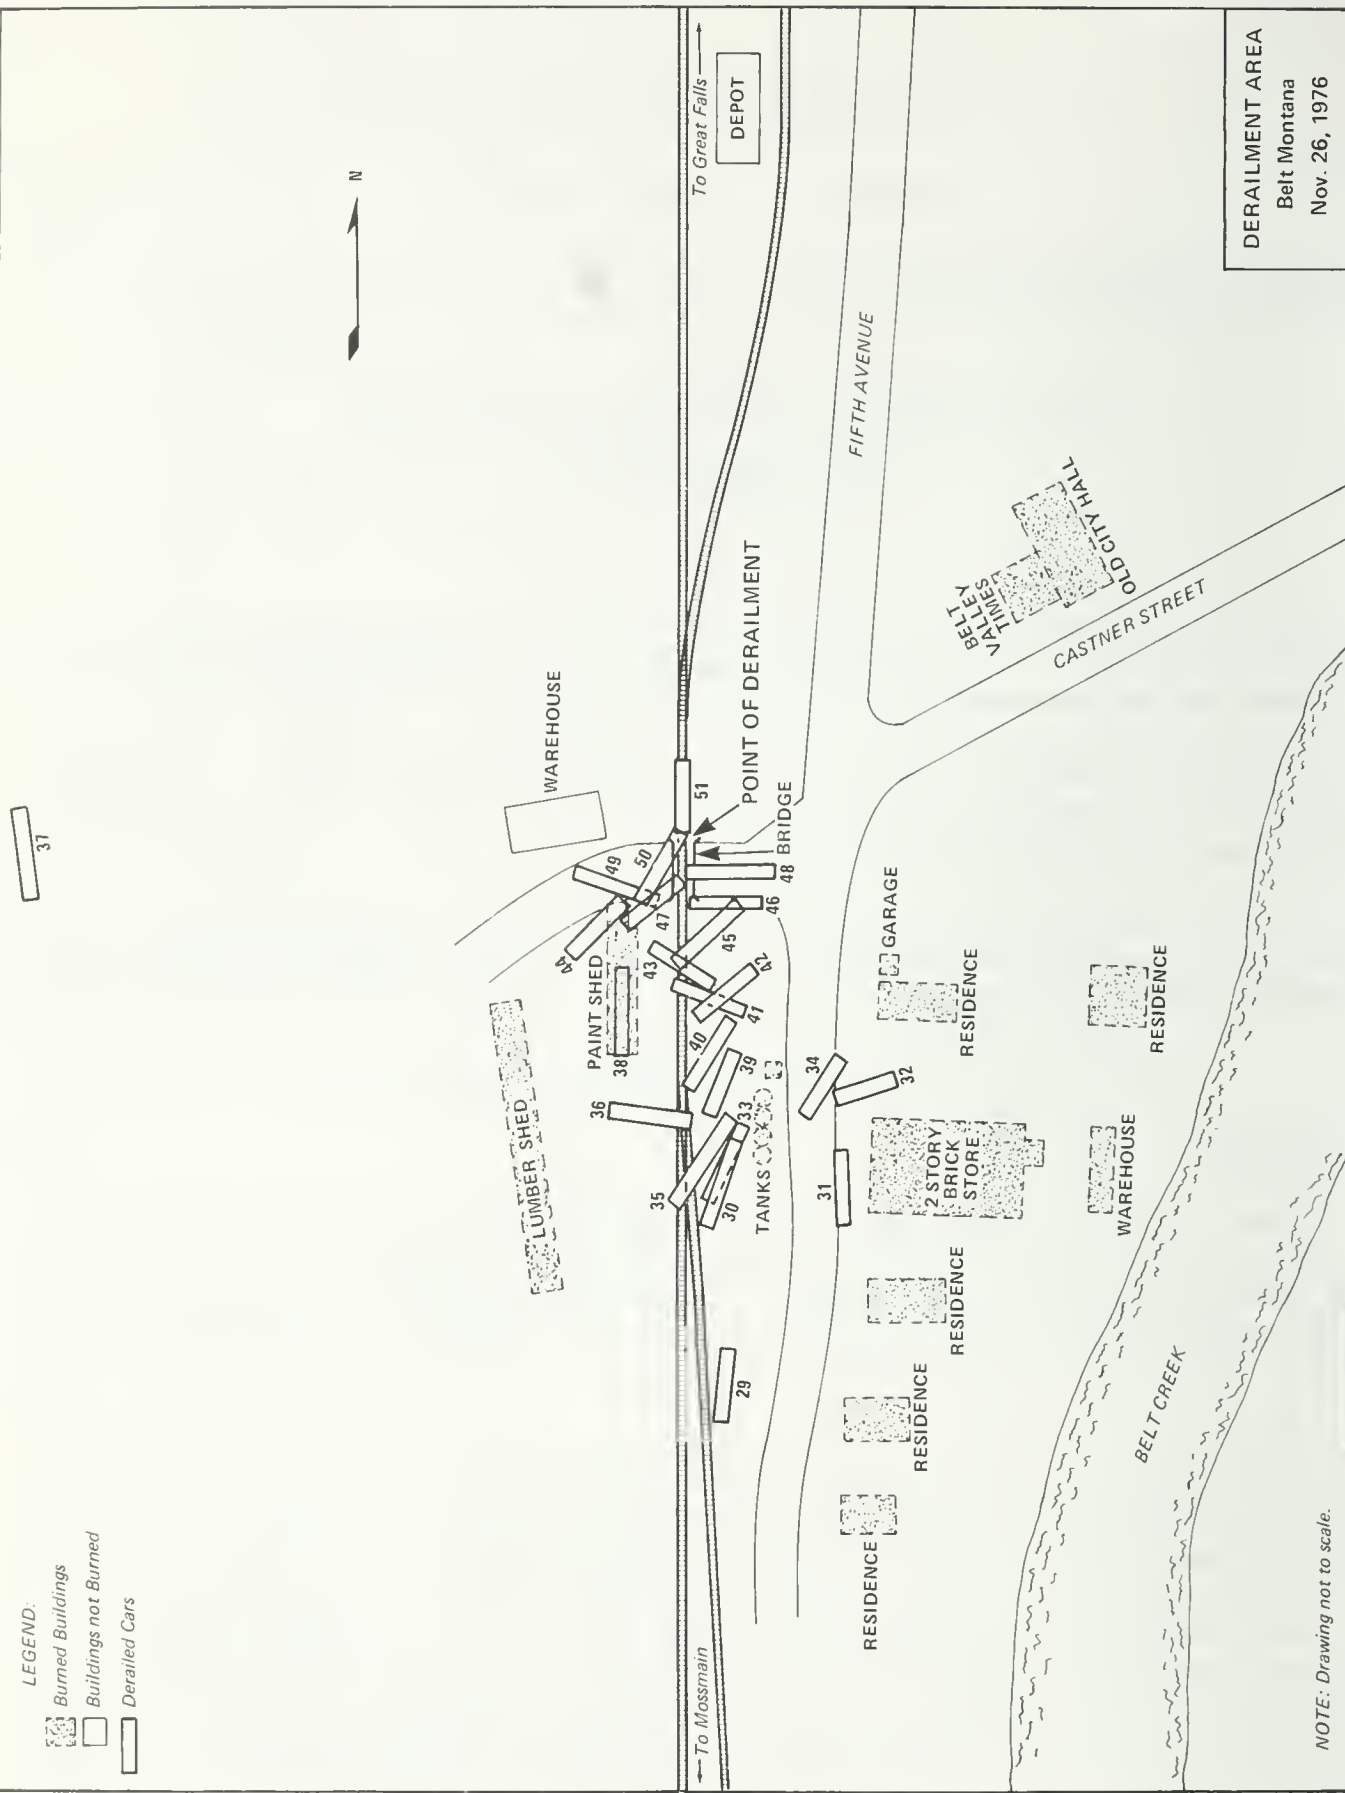
Figure 1. Plan view of accident site.

The initial derailment occurred at the north end of the overpass which carries the single track over Castner Street. The old City Hall building and a newspaper office were about 300 feet northeast of the point of derailment on Castner Street. On the east side of the tracks in the derailment area there were a two-story brick store which belonged to the Farmers Union Cooperative, a warehouse, and several dwellings. In addition, there were four vertical, above-ground, 16,000-gallon tanks for gasoline and fuel oils, two 500-gallon butane tanks, and several small propane tanks. Belt Creek is about 400 feet east of the accident site. A warehouse, a paint storage shed, and a lumber storage shed were on the west side of the tracks. (See figure 1.)

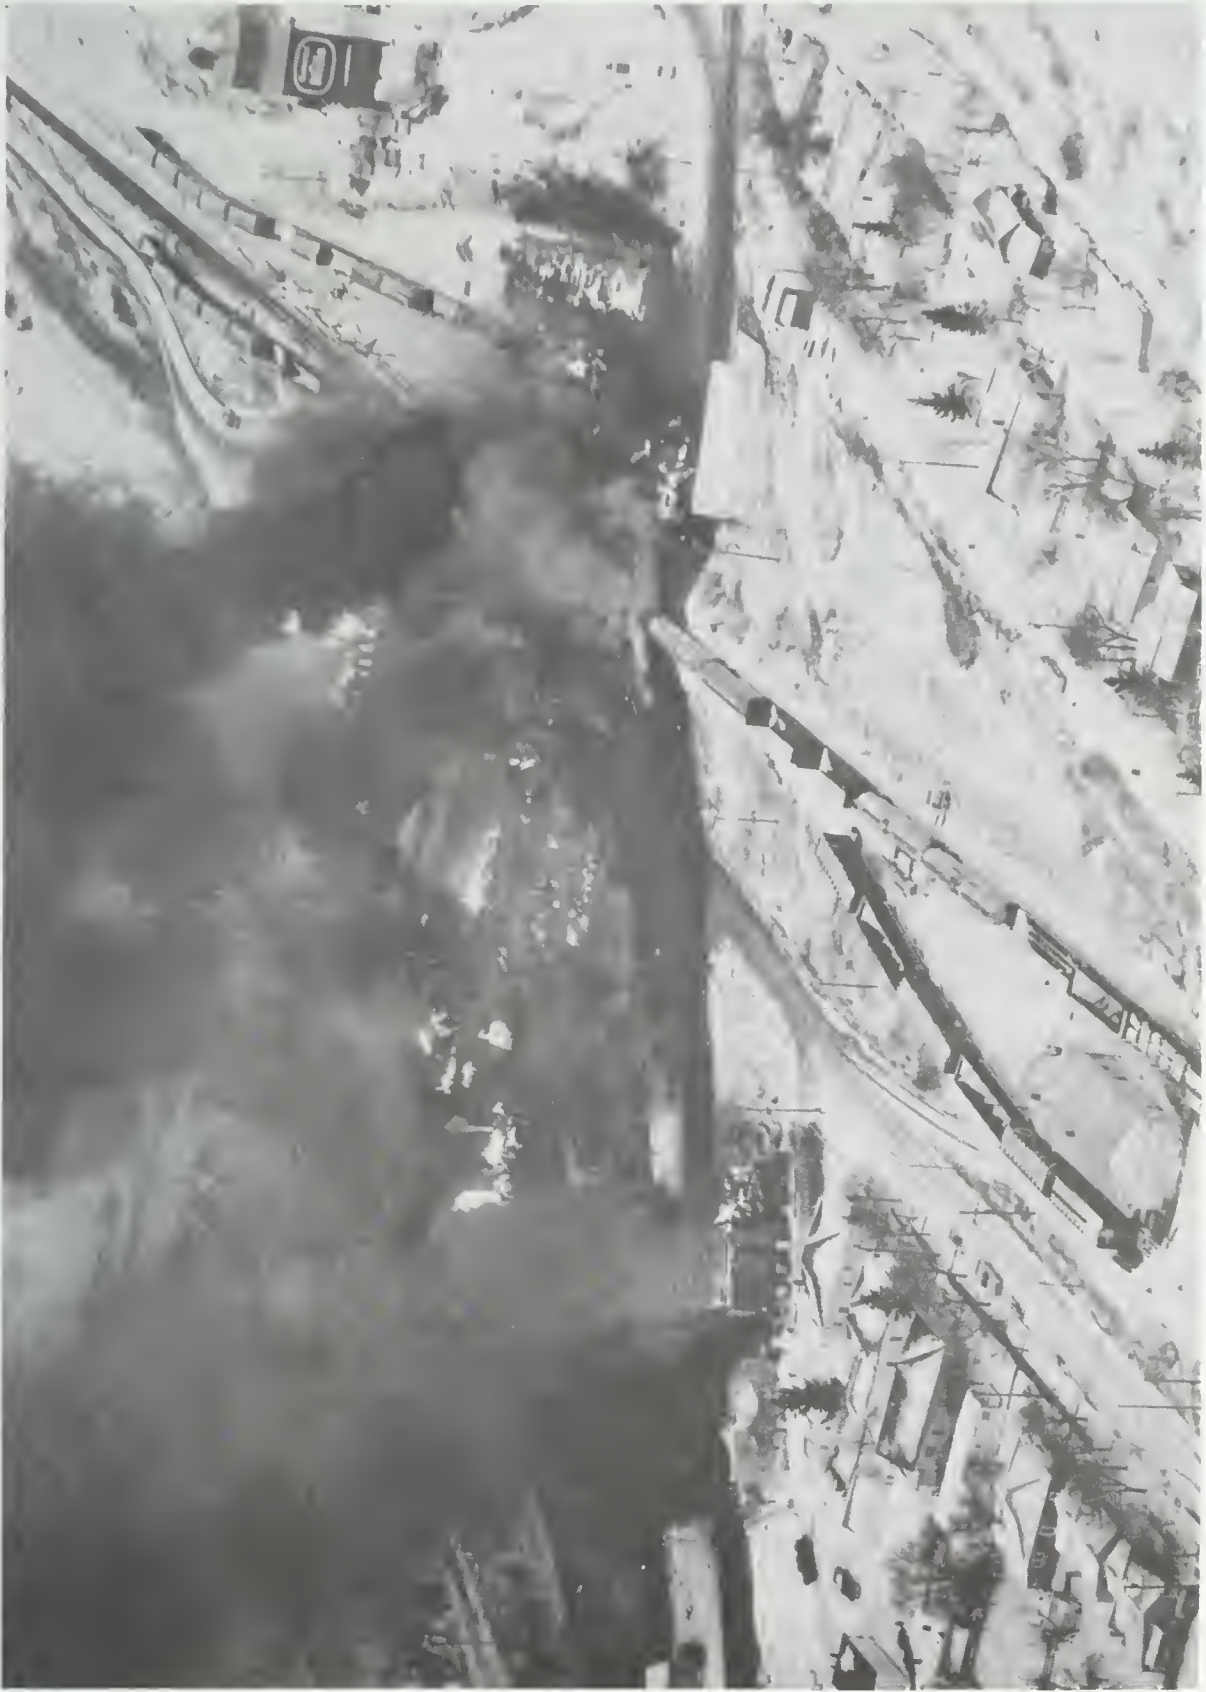
Fire erupted immediately after a tank car collided with the trackside fuel storage tank. Fifty-foot-high flames enveloped derailed cars and buildings within a 300,000-square-foot area around the tank in less than 2 seconds. In a rolling motion the fire advanced eastward toward Belt Creek and spread out to the north and south. Several explosions occurred as the fire burned the derailed cars and nearby buildings. The fires burned for over 12 hours. (See figure 3.)

Figure 3. Aerial view looking south.
